Tests were conducted to determine the mechanism of sodium carryover at 400°F on the EVTm chain hoist system. Tests were conducted in both the EVTm environmental chamber and in controlled atmosphere glove boxes on a series of test coupons with pre-conditioned surfaces.

Tests were concluded in March 1977 on a chain hoist system for the Clinch River Breeder Reactor Ex-vessel Transfer Machine (CRBR-EVTM). These tests subjected the hoist system to 5 years (16,000 cycles) of simulated service in 400<sup>0</sup>F liquid sodium (Ref. 1). Sodium carryover became evident during the initial phases of the test, that is, sodium was deposited on the chain links and transferred to the drive system components (drive pocket-wheel, idlers, takeup pocket-wheel, and pocket-wheel guide caps) as well as to other chain links. As the test progressed, the chain links became completely coated and the quantity of solid sodium deposits transferred to the drive system components increased the drive load such that overloading and/or jamming of the system occurred in two separate incidents.

The objective of this test was to establish the specific conditions required to prevent or limit the amount of sodium tra

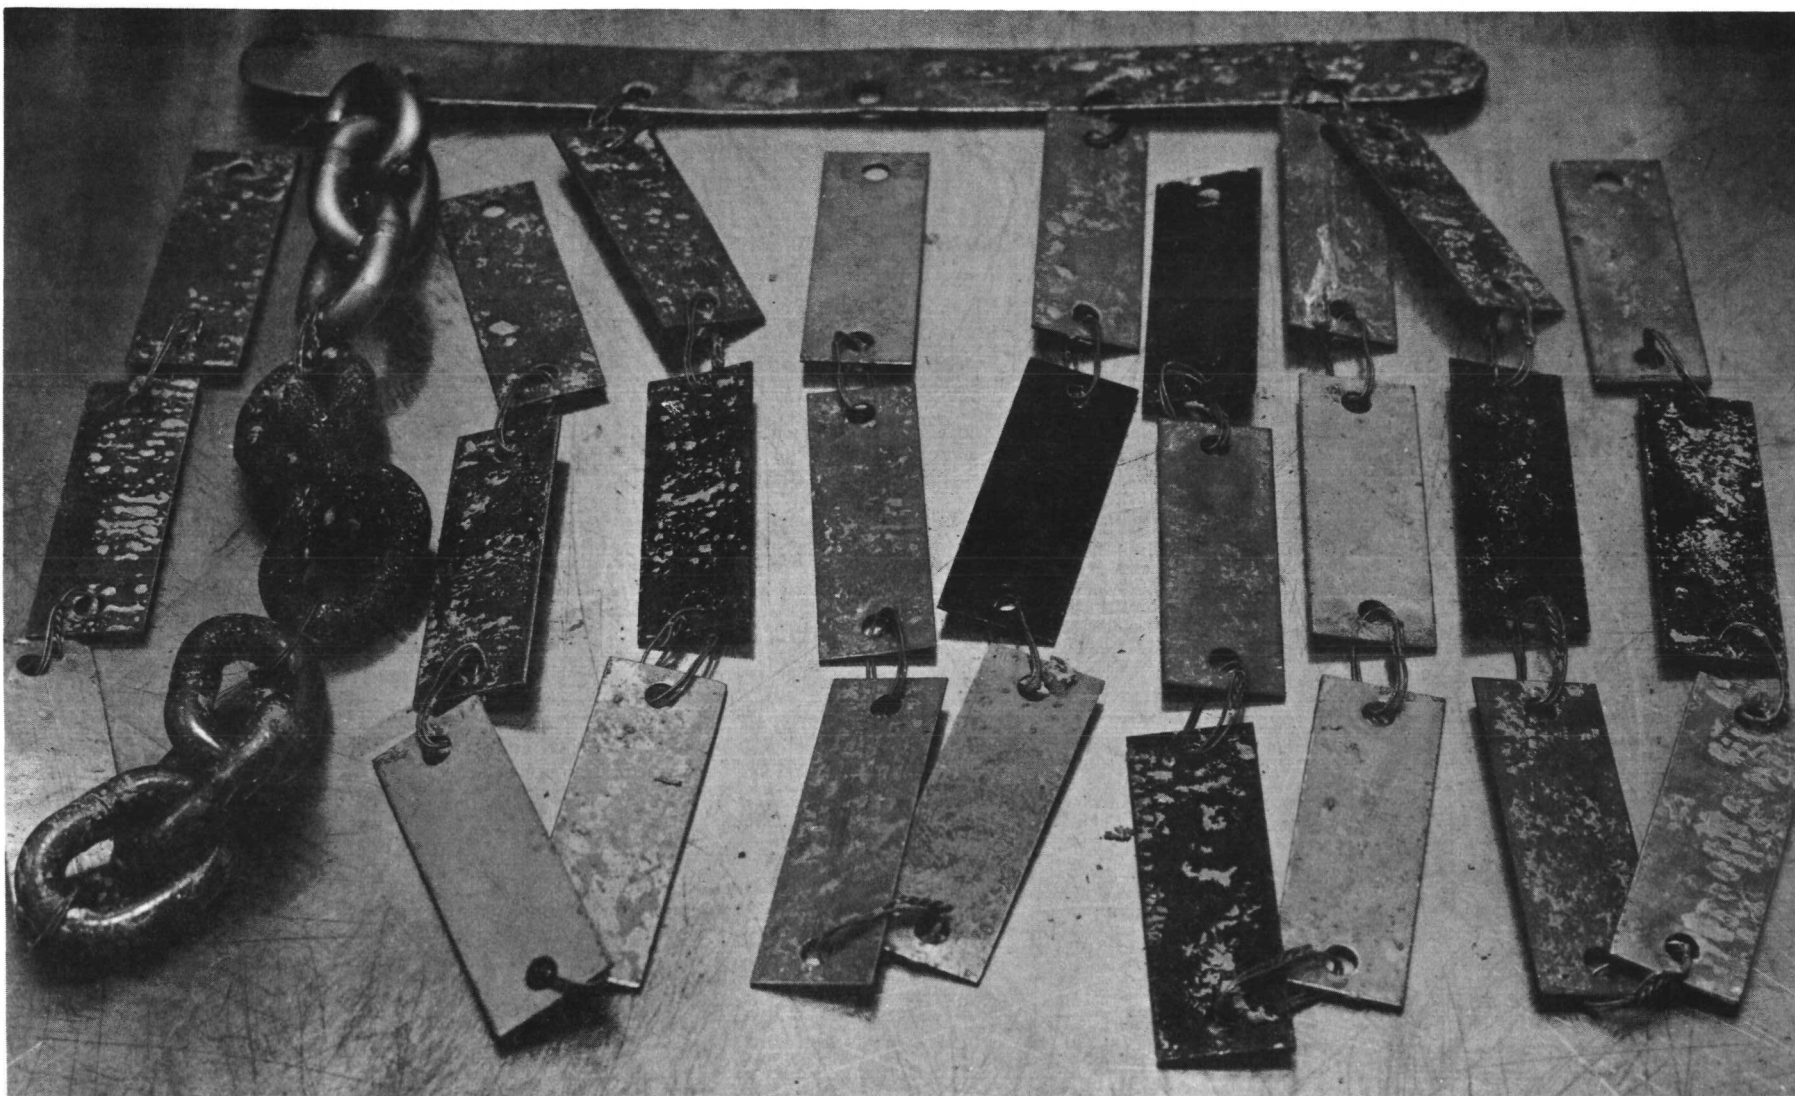
Figure 9.

A third group of test articles; two each of the nine "new" specimens, three new chain specimens, and one each cleaned coupon from Test No. 2, was subjected to over 72 hours of soak in 400°F sodium with no cycling into the argon atmosphere. The two new tin-plated coupons were completely wetted and no other coupons, including the cleaned and reused tin plated coupon, had more than 10% of their surfaces covered by droplets of sodium. This was consistent with previous experience where prolonged immersion in 400°F sodium produced no wetting except to tin-plated surfaces. Figures 8 and 9 show the post-test coupons.

Test No. 3 - Post-Test Coupon Conditions, Side 2

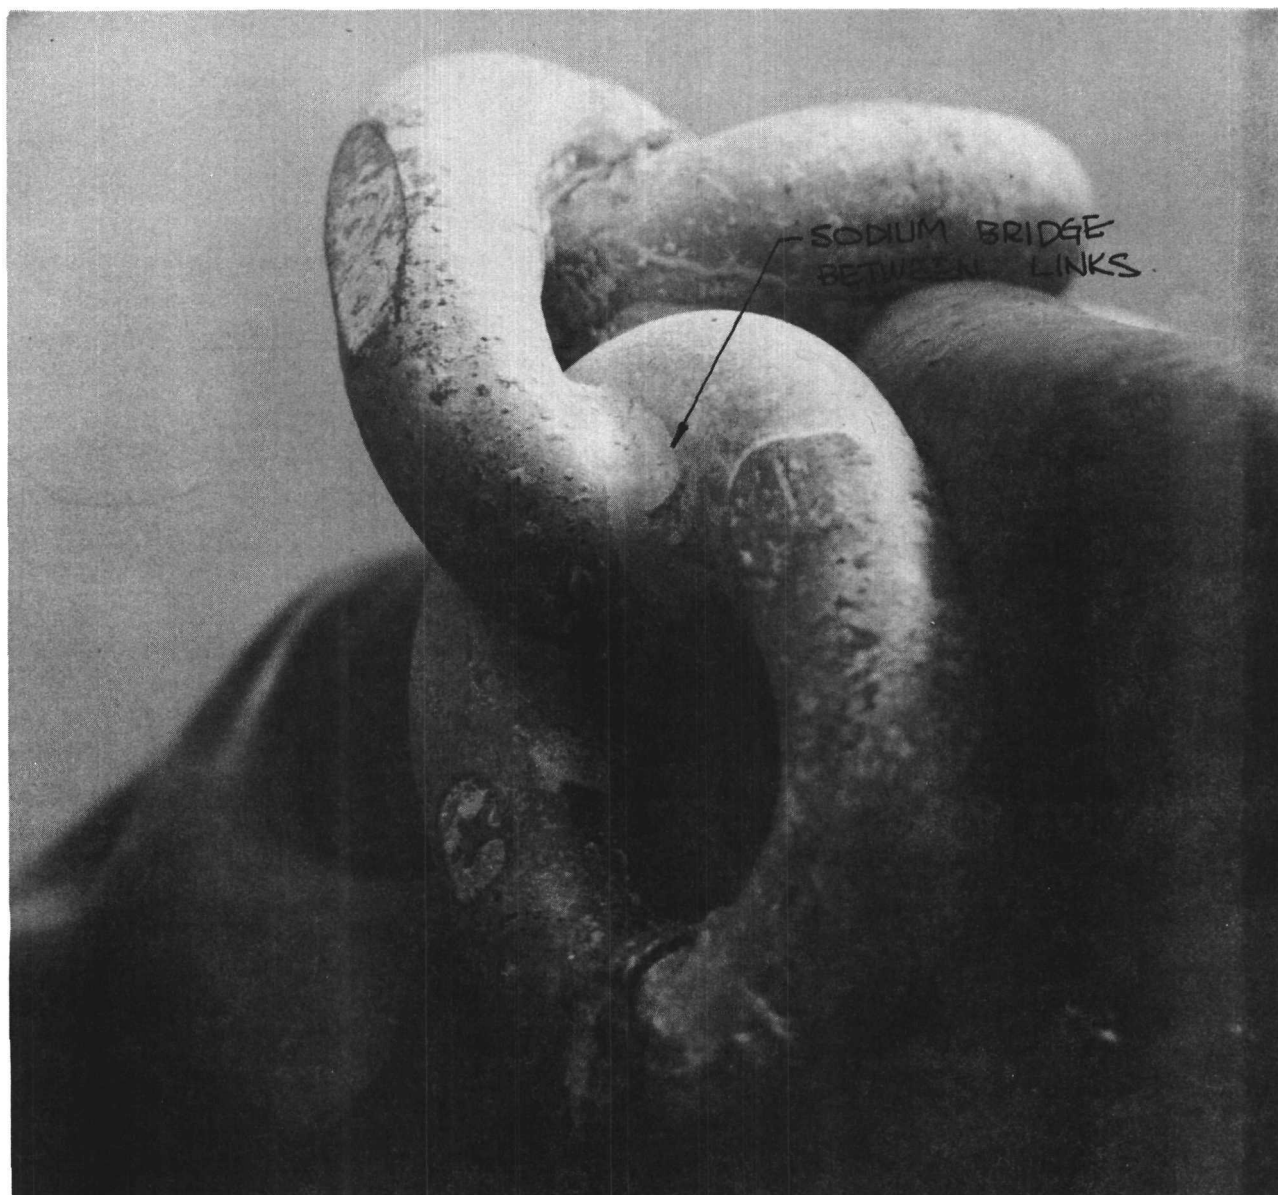
tended to bead up, which should not occur on a fully wetted surface. The post-test coupons are shown in Figure 14 and Figure 15 shows the apparent wetting between immersed chain links. Table IV shows the estimated percent of sodium coating and as with previous tests, indicated little difference in the percent coating of new or used test specimens.

Sodium Bridge Between Chain Links
